Manhole Inspection Summary

Manhole # S35I__008MH

Insp Date: **9/23/08 9:16 AM**

Location Address: **100 light st**

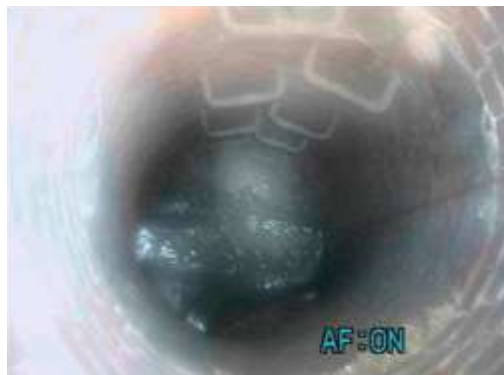
Defect 3

bench debris

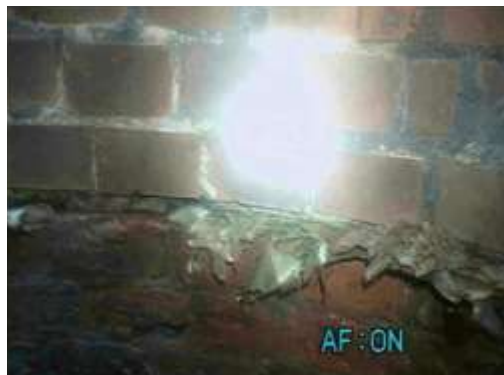
Defect 1

Condition: ☐ Sound ☐ Cracked ☐ Root Intrusion ☒ **Loose Brick** ☐ Deteriorated

chimney loose bricks, frame adj

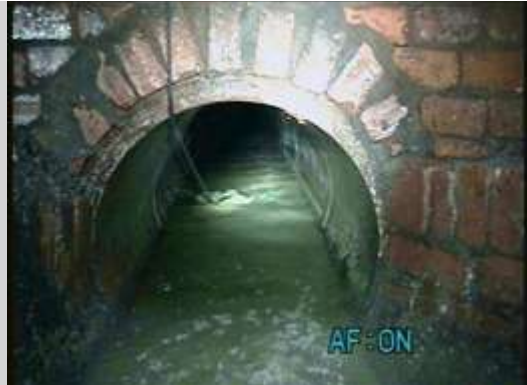
12 O'Clock Outflow

18 in. Circular Gravity Sewer
Pipe Out @ 12 O'Clock

Pipe Material: **Clay** ☐ Pipe Lined

Invert Depth: **14.16** (ft.) Flow Characteristics: **Fast**

Infiltration: **None** Pipe Seal Cond: **Unknown**

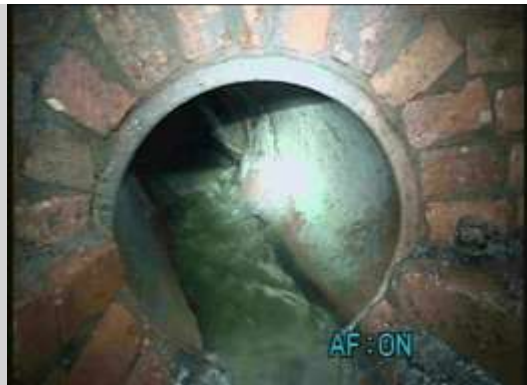
4 O'Clock Inflow

12 in. Circular Gravity Sewer
Pipe In @ 4 O'Clock

Pipe Material: **Clay** ☐ Pipe Lined

Invert Depth: **13.16** (ft.) Flow Characteristics: **Fast**

Infiltration: **None** Pipe Seal Cond: **Unknown**

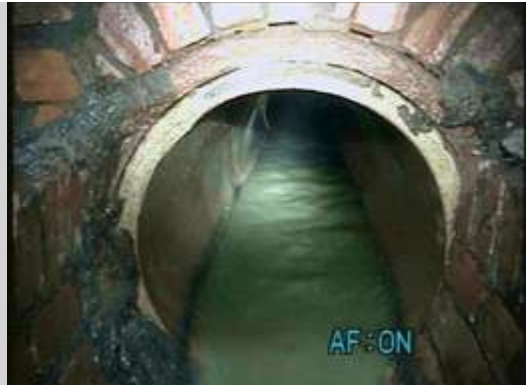
6 O'Clock Inflow

15 in. Circular Gravity Sewer

Pipe In @ 6 O'Clock

Pipe Material: **Clay** ☐ Pipe Lined

Invert Depth: **13.83** (ft.) Flow Characteristics: **Fast**

Infiltration: **None** Pipe Seal Cond: **Unknown**

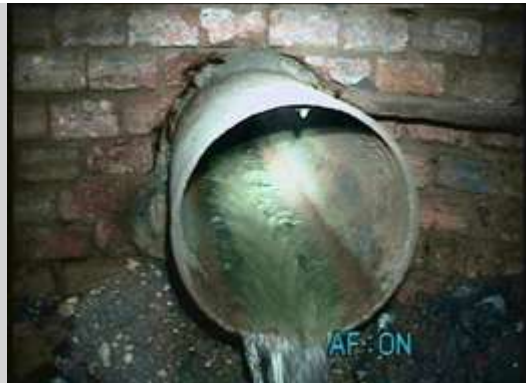
8 O'Clock Inflow

10 in. Circular Gravity Sewer

Pipe In @ 8 O'Clock

Pipe Material: **Clay** ☐ Pipe Lined

Invert Depth: **11.83** (ft.) Flow Characteristics: **Fast**

Infiltration: **None** Pipe Seal Cond: **Unknown**
